October 8, 2018

Champlain Towers South
8777 Collins Avenue
Surfside, FL 33154

**Re: Champlain Towers South Condominium
Structural Field Survey Report
MC Job# 18217**

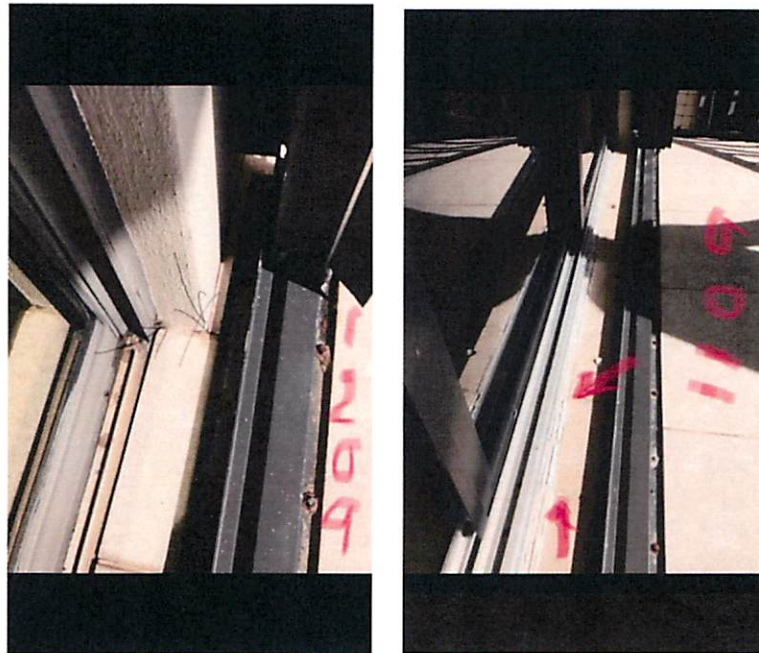
- A. MC understands some unit owners have complained of flooding into the interior space of their unit during a hurricane event. MC has concluded that this infiltration is occurring through the balcony sliding glass doors & windows due to the lack of proper flashing at the sill of these doors & windows and deteriorated exterior perimeter sealant between the window/door frames and masonry/concrete walls. MC recommends that the exterior sealant be removed / replaced at the sliding glass door & window perimeter to assist in providing a water-tight condition. Unfortunately, the new sliding doors in unit 209 and above were not installed properly and were fabricated too tall to allow the base flashing to be properly installed, so these unit owners have no choice but to discard the newly purchased doors and have them completely refabricated.

Figure A1: Exterior sealant past its serviceable lifespan at sealant between the window/door frames and masonry/concrete walls & balcony floors

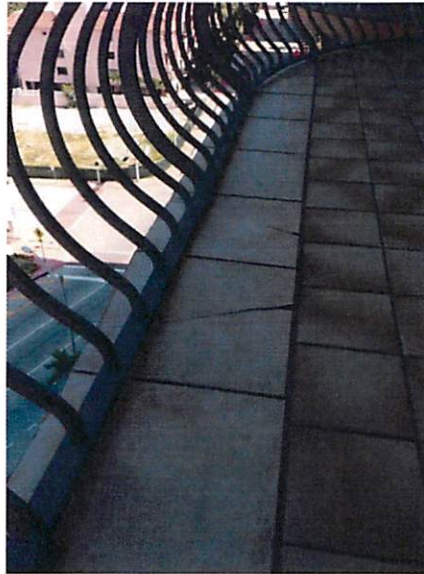
- B. MC observed that the majority of the balconies were furnished with tile or some other floor covering by choice of the tenant, making it impossible to observe the condition of the topside of the balcony slabs. Several instances were noted where balcony tile was damaged, such as in Unit 1008. Based on MC experience, cracked tile usually means structural damage exists to the balcony slab that must be repaired per the requirements of the International Concrete Repair Institute (ICRI) prior to the installation of a pedestrian waterproofing membrane.

Figure B: Damaged balcony tile that must be removed to fix structural damage

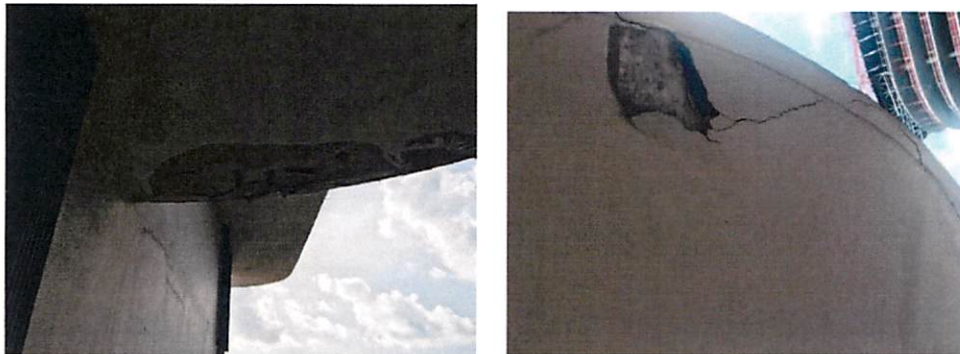
- C. MC found it fairly typical that the concrete slab edges of the balconies are experiencing concrete spalling or cracking. MC sees this as a common source of water infiltration and a main cause of the commonly found, sub-surface deterioration at the exterior soffits under the railings. MC requires that the balcony slab edges be further investigated and repaired in accordance with the recommendations of the ICRI to prevent future water penetration.

Figure C: Concrete spall at balcony slab edge in units 1008 & 211

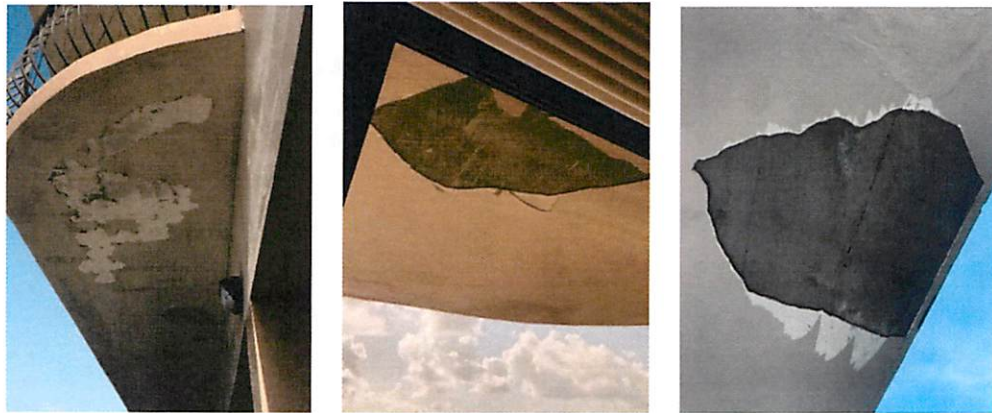
- D. Approximately half of the balcony soffits reviewed by MC show evidence of deterioration under the painted finished surface. These areas were identified by sounding the concrete with a golf club, checking for solidarity. In some cases, the paint finish had formed a bubble or pocket that was retaining water, while in other areas the painted soffit was peeled away leaving the concrete surface exposed. The extensive soffit damage is a systemic issue that can only be repaired by removing all of the balcony tile, repairing the damaged concrete surfaces at the top and bottom of the slab and protecting the slab by installing a pedestrian waterproofing membrane on all top-side balcony surfaces. Partial/full depth concrete repairs in these areas shall be performed in accordance with the recommendations of ICRI. It is important to note that installing tile on top of the concrete balcony surfaces results in the railing having inadequate height to meet the minimum guardrail height of 42" required by the Florida Building Code.

Figure D: Balcony Soffit paint spalling in units 208, 703, & 1301.

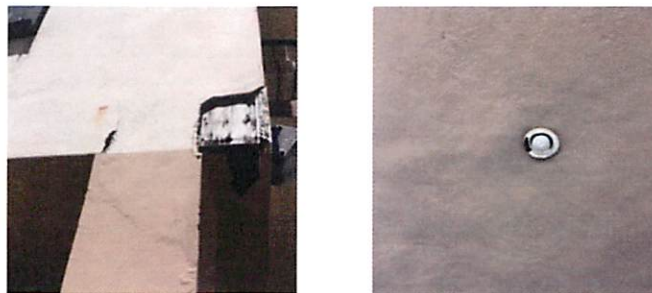
- E. Several areas of the entrance drive soffits under the second floor were observed by MC to have deteriorated black plywood. This condition was also observed at several light fixtures in the entrance soffit. MC could not get access into the soffit areas to observe the extent of the deteriorated soffits and support framing as CTS maintenance was too busy to assist us. MC is concerned that mold exists above these soffit areas and the soffit support framing is deteriorated which will require the complete removal and replacement of the entrance suspended soffit. Further investigation into this area is warranted.

Figure E: Deteriorated plywood soffit above entrance drive.

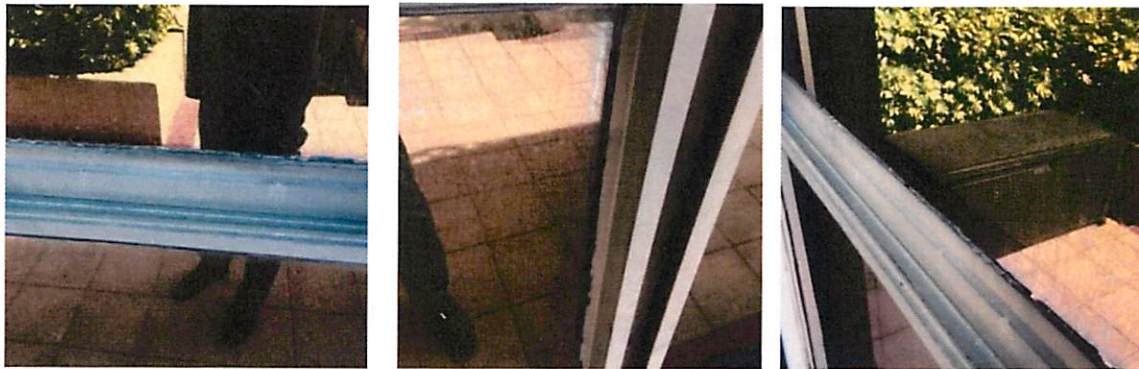
- F. It was brought to MC's attention that several units are experiencing water infiltration through the window frames and glazing as the windows are near the end of their functional lifespan. It is recommended that the window frame glazing (metal to glass), and perimeter sealant (metal to metal or metal to masonry/concrete) be removed and replaced for the entirety of the building to reduce future water penetration and minimize damage during hurricane events. MC recommends that the BOD strongly consider the replacement of all exterior windows and doors with impact resistant units.

Figure F: Exterior sealant at window frame that has aged past its serviceable lifespan

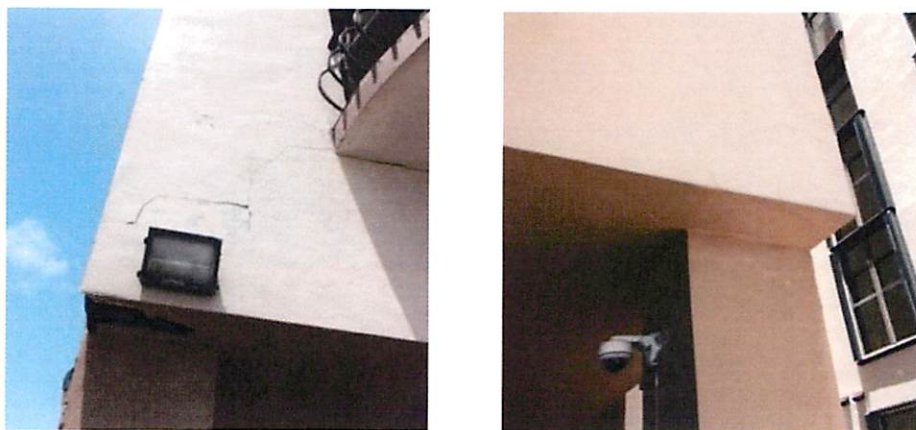
- G. Significant cracking in the stucco exterior façade often occurs at the mortar bed joint between the top of the concrete floor slab and first block masonry course. Although MC does not see this crack as a source of water infiltration into the condominium units, such cracks need to be routed and repointed to prevent future water permeation. All significant façade stucco cracking is to be repaired in accordance with the recommendations of ICRI.

Figure G: Typical cracking in the stucco exterior facade.

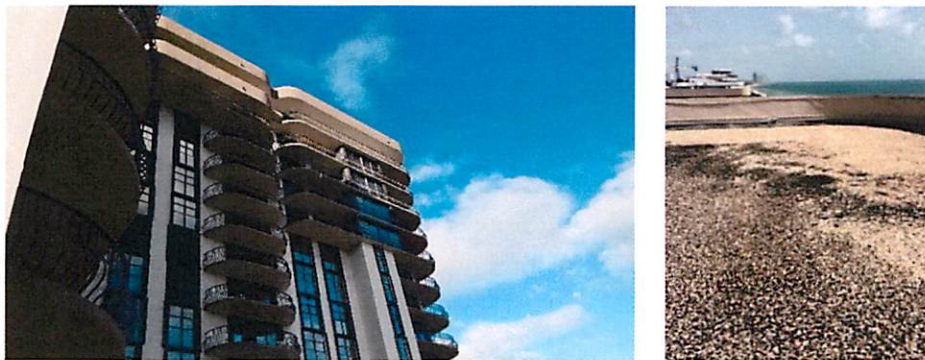
- H. MC observed the non-existence of window washing / suspension hooks that should have been installed face-mounted to the underside of the top-level balconies and spread throughout the roof of this building structure. This failure to have suspension hooks is a violation of the present-day **Occupational Safety and Health Administration (OSHA) Rules and Regulations 29 CFR Part 1910 "Walking-Working Surfaces and Personal Protective Equipment (Fall Protection systems)"** requirements and **ANSI/IWCA I-14.1-2001 "Window Cleaning Safety Standard"**. MC recommends that new hooks be installed and waterproofed on the roof structural slab and underside of the top-level balcony slabs that meet the requirements of **OSHA 29 CFR Part 1926.502 "Fall Protection Systems Criteria and Practices"** and **ANSI/IWCA 1-14.1** prior to the commencement of façade and balcony restoration. Furthermore, MC recommends that our office meet with the contractor who is to perform the façade restoration work and the present window washing contractor so that the new fall protection system anchor quantity and location can be agreed upon to assure adequate anchor coverage for all future contractors who will be suspended on the exterior of the Champlain Towers South Condominium.

Figure H: No suspension hooks at the underside of the balconies and on the roof.

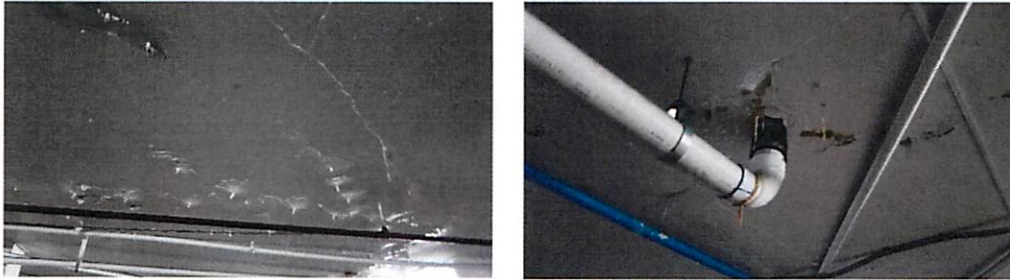
- K. MC visual observations revealed that many of the previous garage concrete repairs are failing resulting in additional concrete cracking, spalling and leaching of calcium carbonate deposits. At the underside of Entrance/Pool deck where the slab had been epoxy-injected, new cracks were radiating from the originally repaired cracks. The installed epoxy is not continuous as observed from the bottom of the slab, which is evidence of poor workmanship performed by the previous contractor. The injection ports were not removed, and the surfaces were not ground smooth at the completion of the injection. Leaching of calcium carbonate deposits in numerous areas has surely caused CTS to pay to repaint numerous cars. This leaching will continue to increase until proper repairs are completed. MC is convinced that the previously installed epoxy injection repairs were ineffective in properly repairing the existing cracked and spalled concrete

Figure K1: Previously installed failed injection repairs with leaching forming

slabs. MC recommends that the Entrance/Pool deck concrete slabs that are showing distress be removed and replaced in their entirety. Unfortunately, all of these failed slab areas are under brick pavers, decorative stamped concrete and planters which require completed waterproofing replacement. All repaired concrete slabs located in the parking garage are to be repaired in accordance with the recommendations of ICRI.

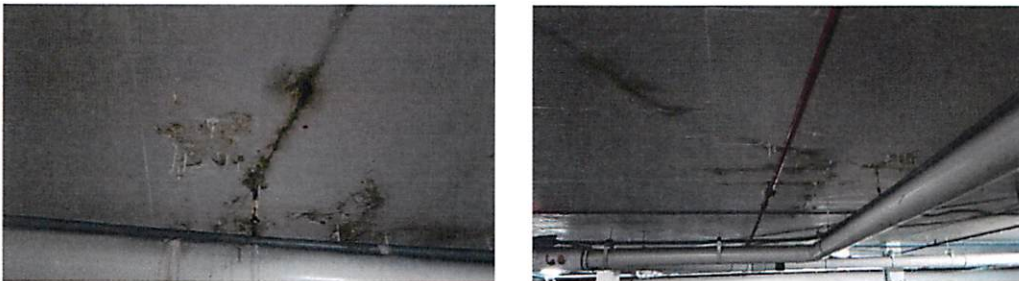
Figure K2: More previously installed failed injection repairs with leaching forming
