**Civil Code 5551 (SB 326) Application
Consensus among CA Reserve Study Providers, Jan 2020
(revised and updated Feb 3, 2020)**

Objective: to discuss this issue among statewide Reserve Study providers in order to provide a high level of service to the community associations of CA with a consistent application of CC 5551. Success will mean minimized confusion among associations, and a consistent set of expectations among clients, attorneys, and managers. This document contains no legal advice.

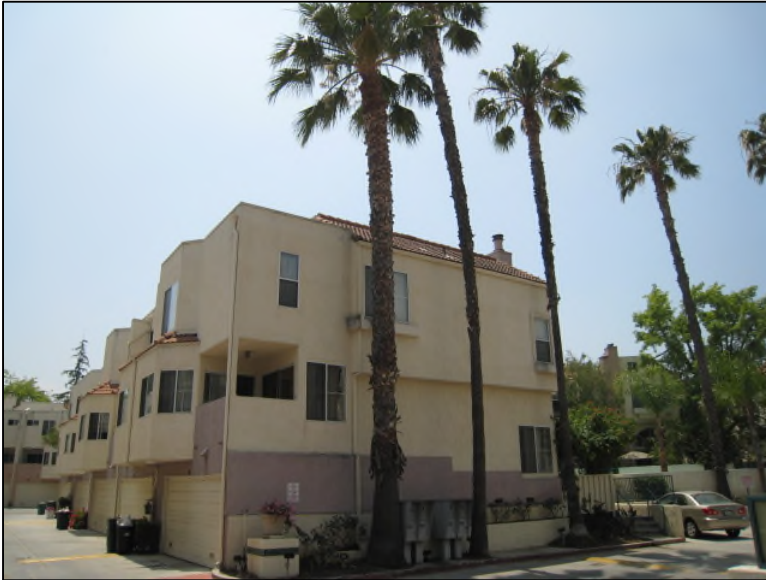
5551 does not apply. This corner balcony does not extend beyond the exterior walls of the building.

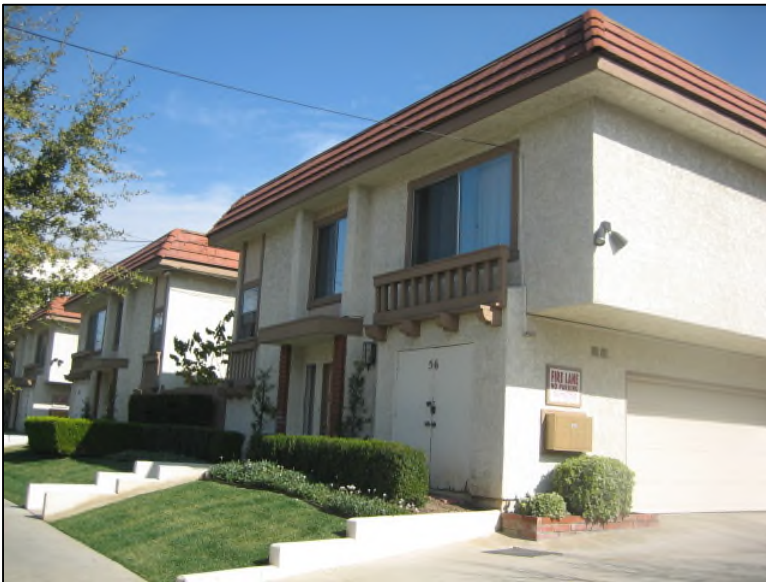
5551 does not apply. The "faux" balcony outside/below the window is not a structural element designed for human occupancy. It is trim. The roof over the doorway is a roof, not a structural element designed for human occupancy.

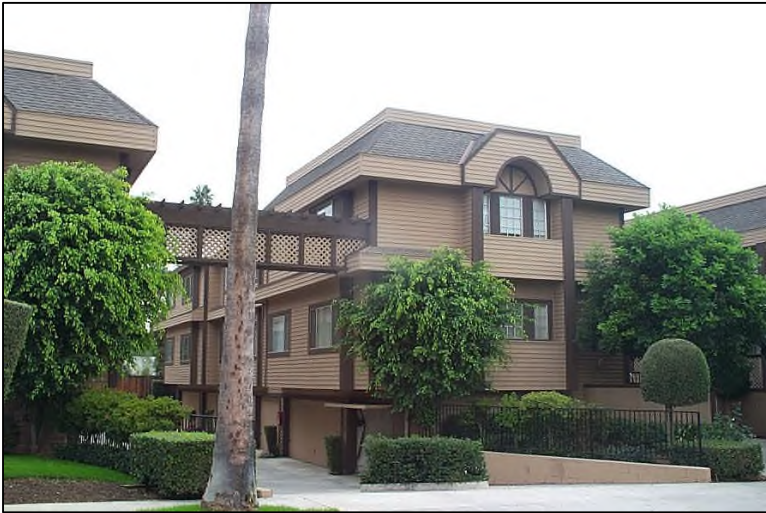
5551 does not apply. The decorative element between buildings, over the driveway, is not meant to support humans.

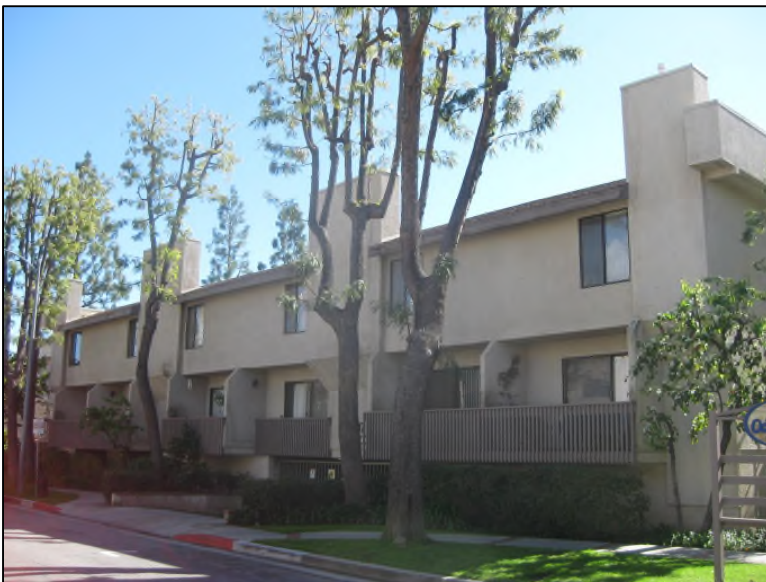
5551 likely applies. While the balcony may not be (exactly) in excess of 6' above ground, we wouldn't want a loved one with a small child to be on it when it fell. Recommendation: be generous in your application of the 6' above ground standard.

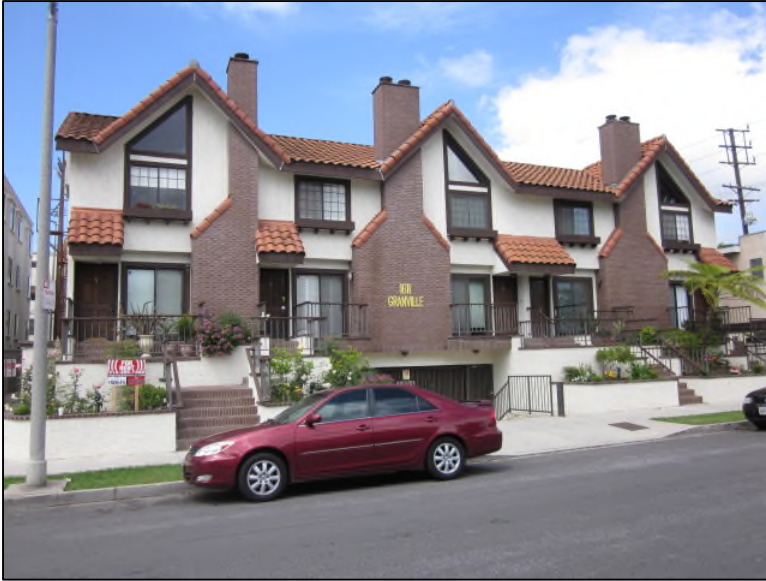
5551 likely applies. While the side patios are not overhanging areas (fall-able), the presence of the two “balconies” over the driveway to the underground garage are true balconies, with a dangerous 6’ (or more) potential fall risk.

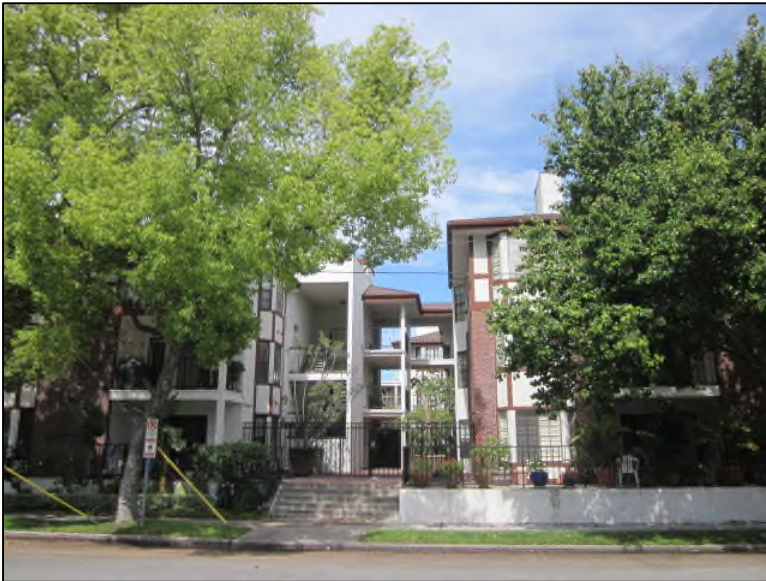
5551 likely applies. The stairwell area projects from the exterior wall of the building.

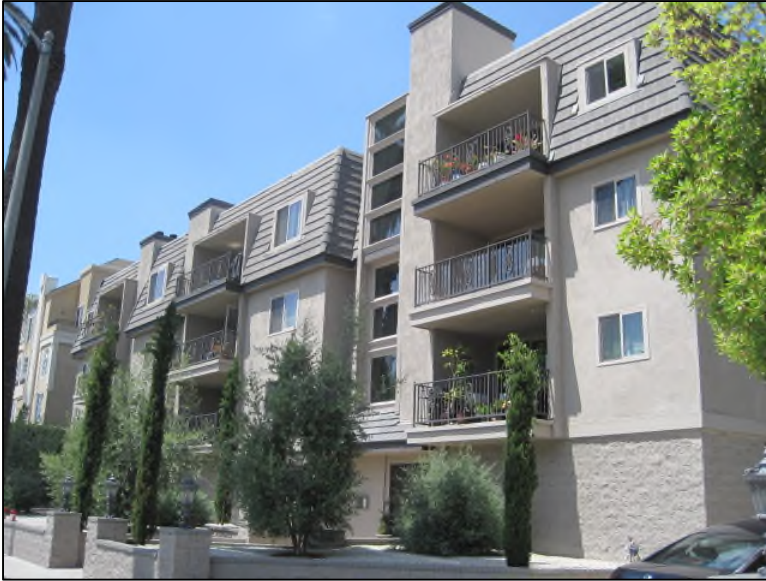
5551 likely applies. While the bulk of the balcony is within the exterior profile of the building, there is a projected portion and leaning against the railing is potentially hazardous.

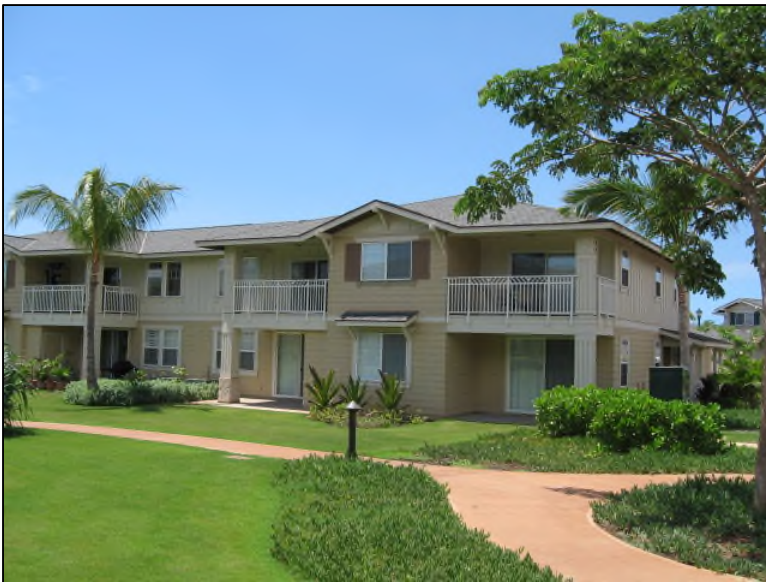
5551 likely applies. While under the roof line, the balcony projects from the building exterior surface, is supported by a corner column, and is “fall-able”.

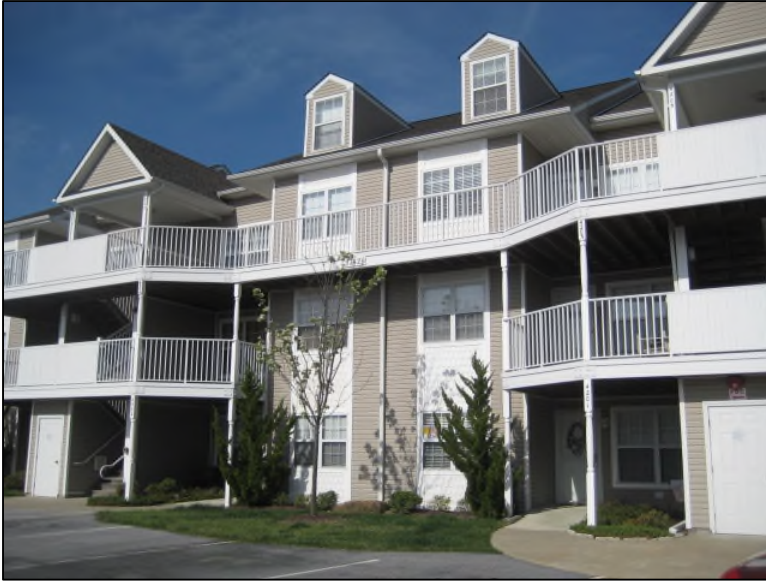
5551 likely applies. Balconies are supported by columns, and surfaces project from the exterior envelope of the building.

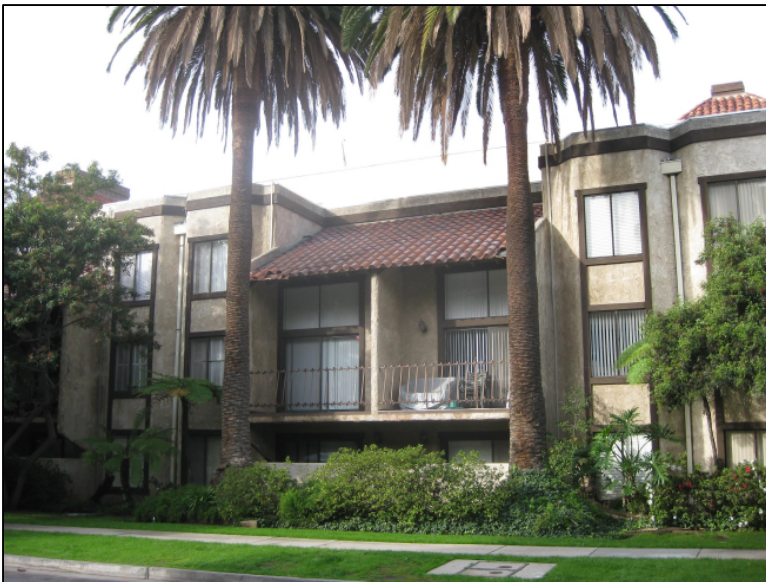
5551 likely applies. Marginally 6' above ground, but it presents potential danger/harm to anyone on it if it fell, or if they leaned against the railing.

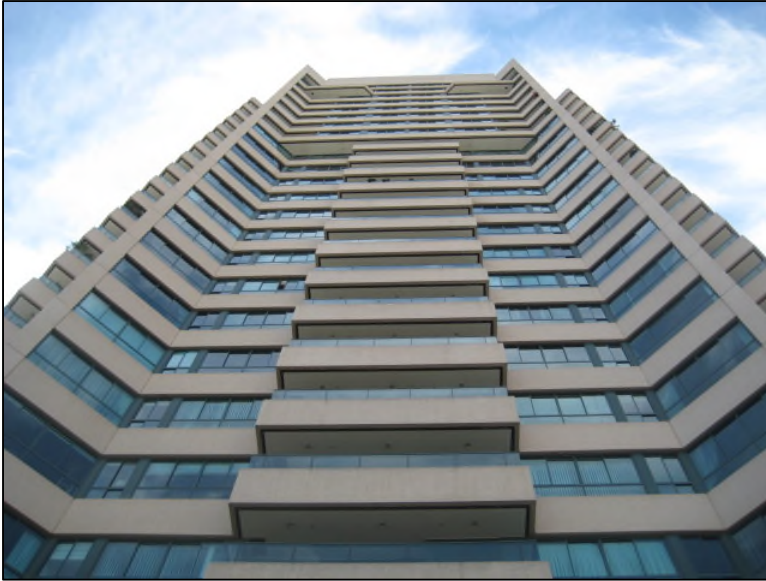
5551 does not apply. No wood or wood-based balconies on this high-rise (although it may be wise to recommend a safety inspection).

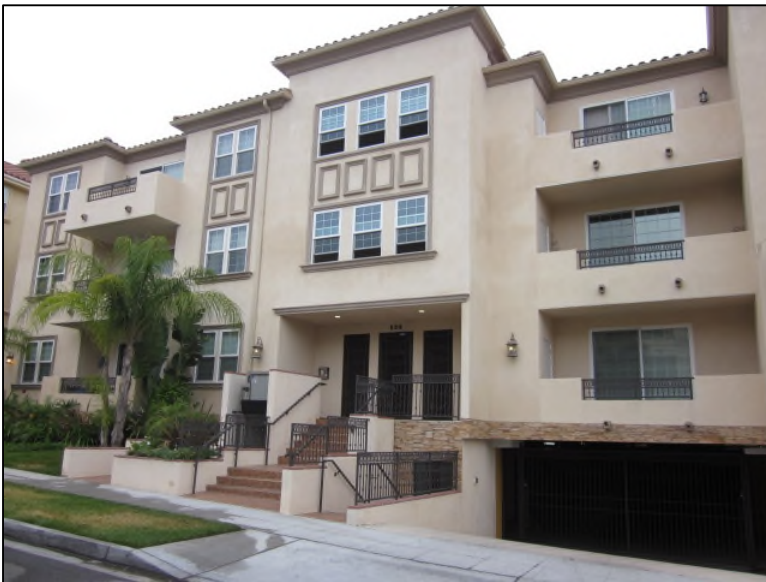
5551 likely applies. Balconies on right (above driveway) project beyond exterior envelope of building and roof line, and are definitely fall-able. Balconies in left of photo clearly project far beyond exterior of building envelope.

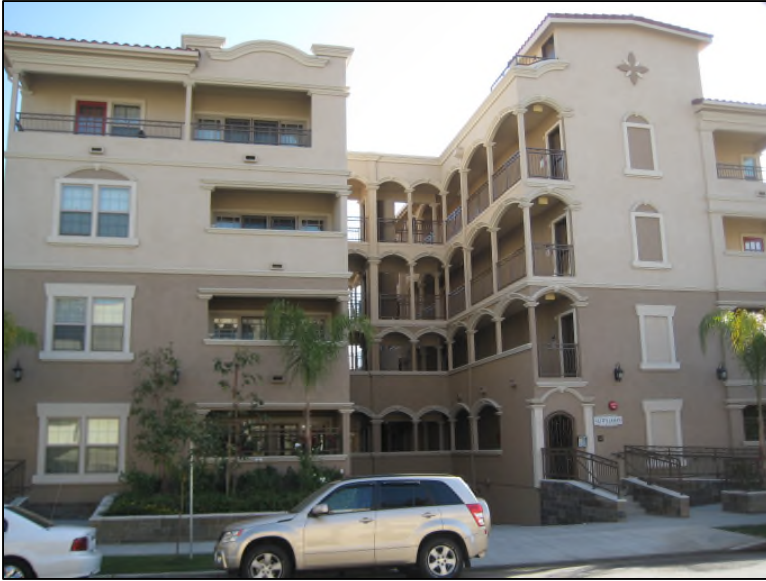
5551 likely applies. Elevated walkway areas designed for humans supported by columns. Note that balconies on left side of photo appear to be within envelope of building, thus not fall-able.

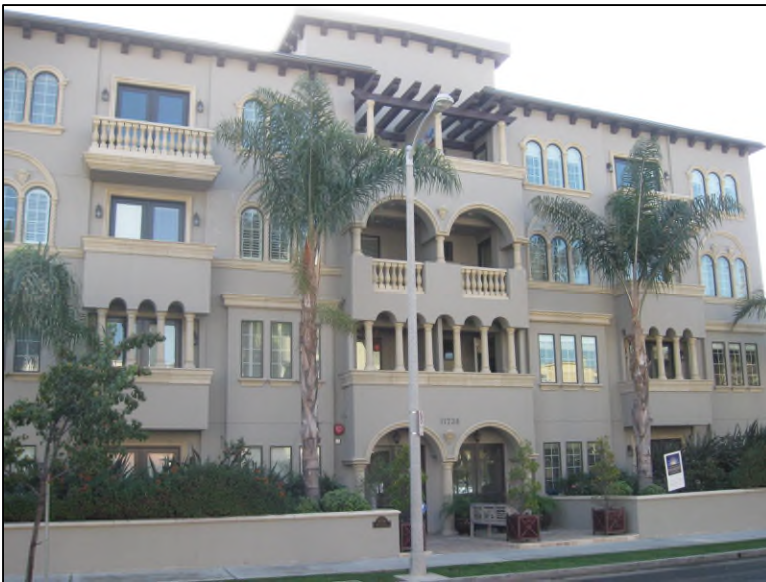
5551 likely applies. While balconies outside sliding doors may be very shallow, they project from building envelope and thus are fall-able.

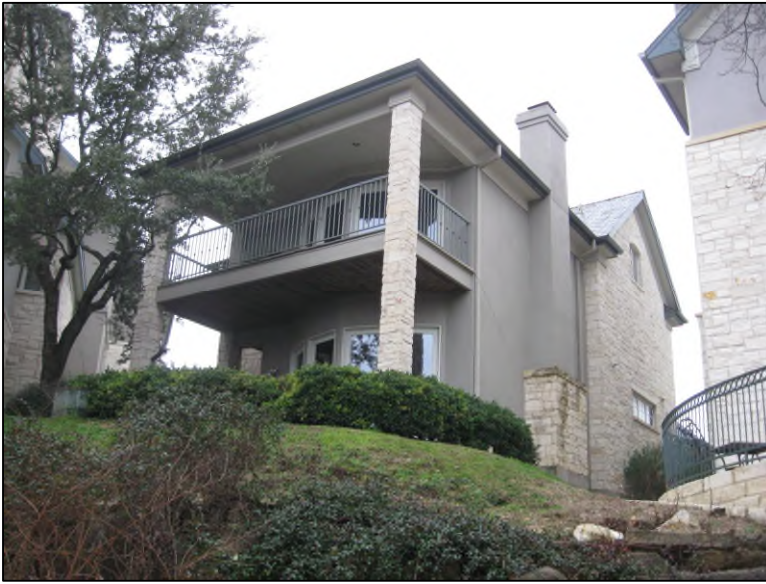
5551 likely applies. While under the roof line, this balcony projects from the building exterior surface and is supported by columns. Expect the rock on the column is just veneer over wood structure.

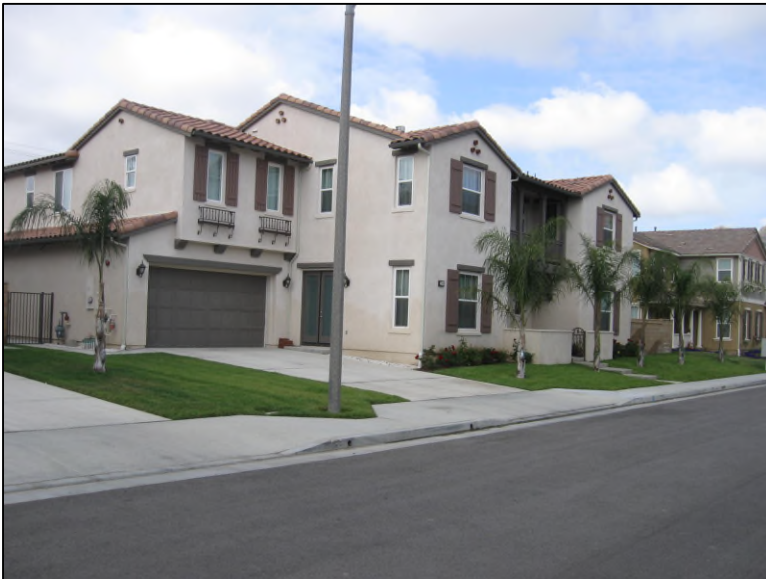
5551 does not apply (presuming this to be condo, and ignoring anything over front walkway entrance).

Ironwork below windows is just decorative trim, not a structural projection from the building exterior envelope designed to hold humans.
